Reference: EPA Contract No. 68-W4-0006; Work Assignment No. R05052
Environmental Priorities Initiative (EPI) Assessments; Siemens-Furnas
Controls, Inc., Batavia, Illinois, EPA ID No. ILD005129069; PA/VSI Report
and NCAPS Scoring Report; Task 04 Deliverable

**PRELIMINARY ASSESSMENT/VISUAL SITE INSPECTION
FOR
SIEMENS-FURNAS CONTROLS, INC.
EPA ID No. ILD005129069
1000 McKEE STREET
BATAVIA, ILLINOIS**

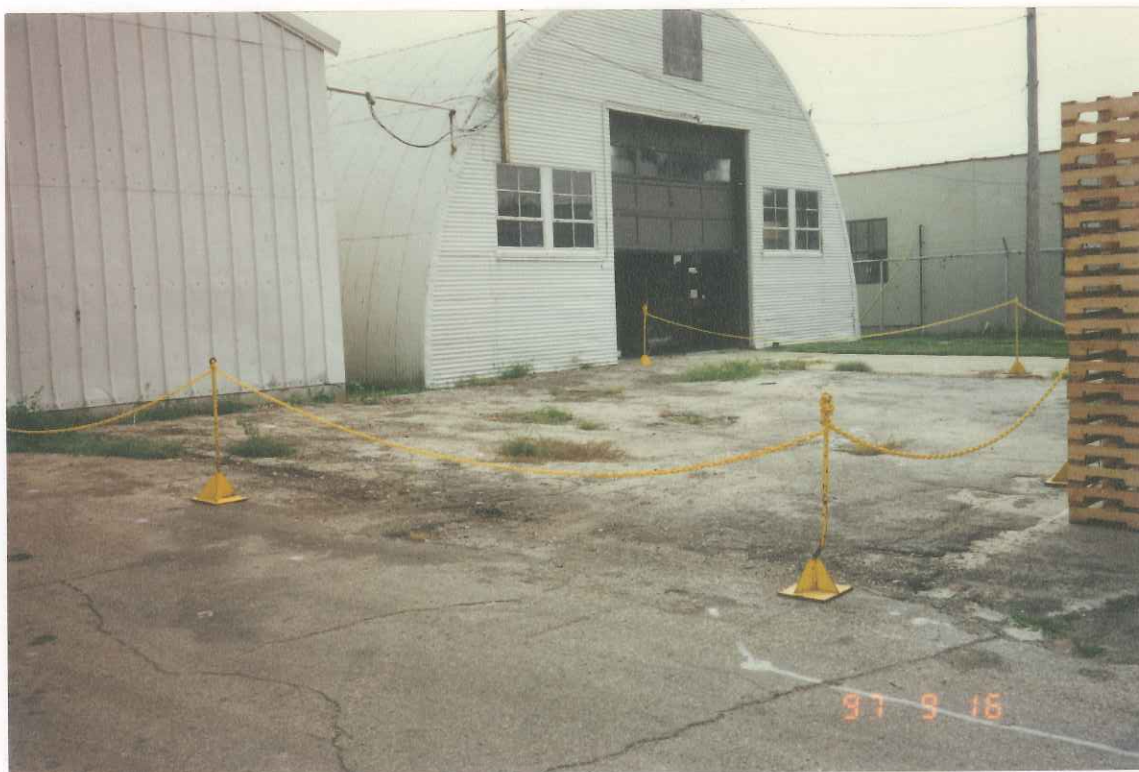
Report Photo No.: 1
Log Book Photo No.: 1-15
Date: 09/16/97

Description: View showing the Former Drum Storage Yard (SWMU 1) located adjacent to the shipping and steel storage area at the southwest corner of the main building. The unit is an asphalt pavement measuring approximately 30 feet by 30 feet in area.

Physical Description: This unit consists of a 30 square-foot asphalt paved area that was previously used to store hazardous waste. The area is approximately 30 x 30.5 feet in size. There is no curb or containment structure around the unit's perimeter. The asphalt layer is reported to be three inches thick and is constructed over a gravel layer. At the time of the VSI, the asphalt was observed to be cracked in several places, and the perimeter of the storage area was cordoned off with yellow tape. According to facility representatives and file materials, the unit was surrounded by a fence with a gate during its operation. Immediately adjacent to the Former Drum Storage Yard, a grassy area was used for the storage of roll-off containers and empty drums (Report Photo 2).

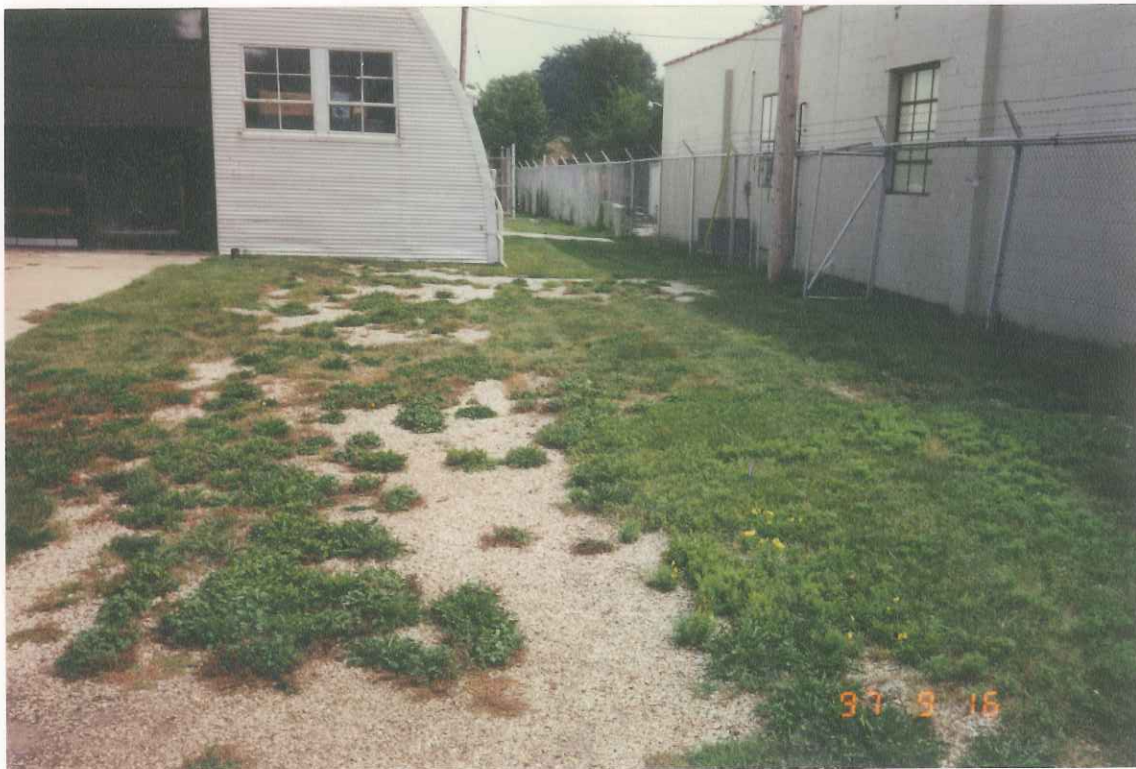
Report Photo No.: 2
Log Book Photo No.: 1-16
Date: 09/16/97

Description: View showing the area adjacent to the Former Drum Storage Yard (SWMU 1). It spans an area of approximately 40 feet by 30 feet. This photograph was taken to provide more information on the appearance of the area immediately adjacent to the Former Drum Storage Yard (SWMU 1).

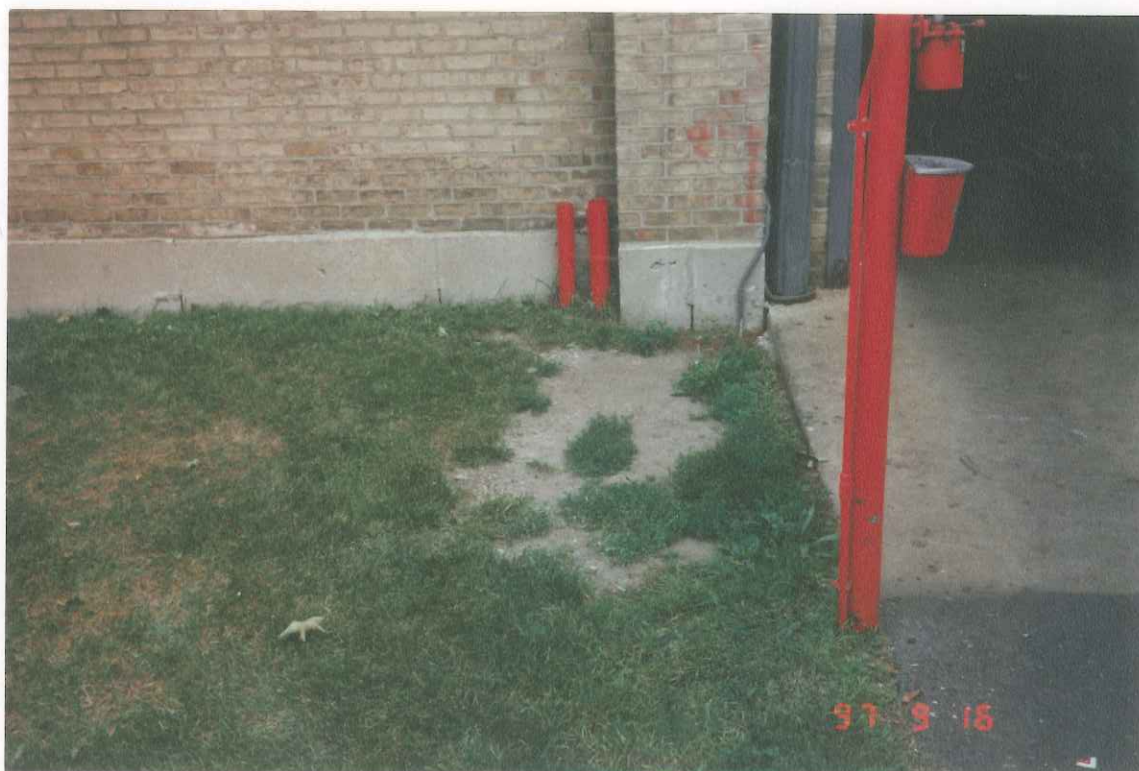
Report Photo No.: 3
Log Book Photo No.: 2-3
Date: 09/16/97

Description: View showing Former TCE Cupful Disposal Area (SWMU 2). The area is directly adjacent to the walkway leading to the northwestern entrance to the main plant.

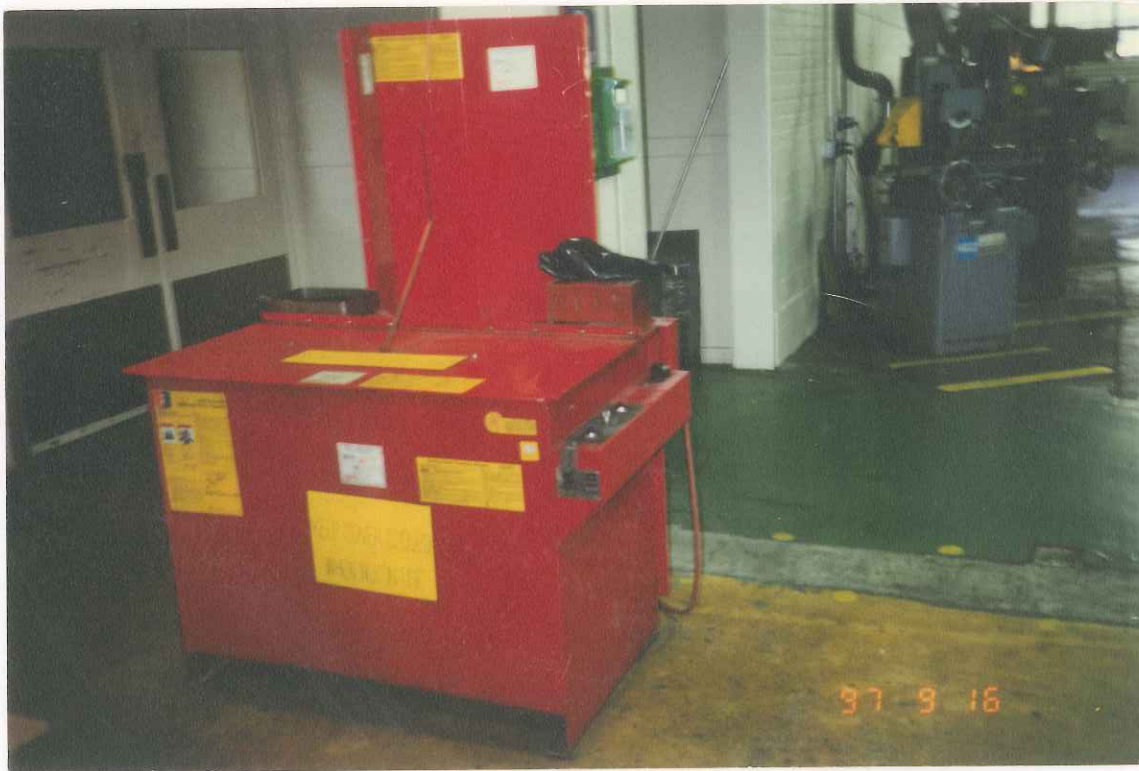
Report Photo No.: 4
Log Book Photo No.: 1-1
Date: 09/16/97

Description: View showing the Safety-Kleen Parts Washer (SWMU 3a) unit located in the tool room. The capacity of this unit is approximately 55 gallons.

(a) - Tool Room. This unit is a lidded tank approximately three feet deep by five feet wide by four feet tall. Inside the unit is an approximately 50 gallon tank of solvent used to clean the parts. The unit is elevated four inches from the floor by steel legs. The sealed concrete floor was free of stains at the time of the VSI and had minor cracking. This unit has been operational since 1990.

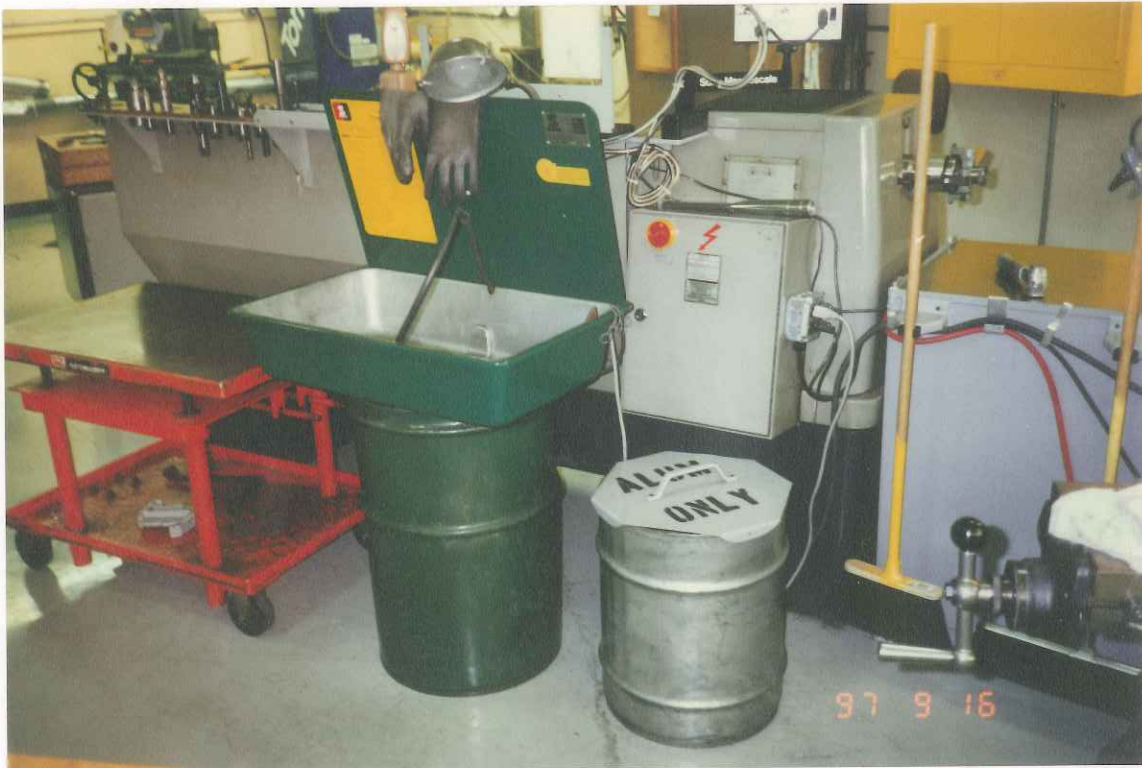
Report Photo No.: 5
Log Book Photo No.: 1-9
Date: 09/16/97

Description: View showing Safety Kleen Parts Washer unit located in the Automation Room (SWMU 3b). The unit is a metallic tub measuring approximately 18 inches by 36 inches by 6 inches. The tub is set atop a 30 gallon metallic drum.

(b) - Automation Room. This unit is a lidded metal tub, approximately 18 inches deep by 36 inches wide by 6 inches tall. The tub drains directly to, and sets above, a metal drum estimated to be 30 gallons in capacity. The drum sets directly on the sealed concrete floor which was free of stains and cracks at the time of the VSI. This unit has been operational since 1991.

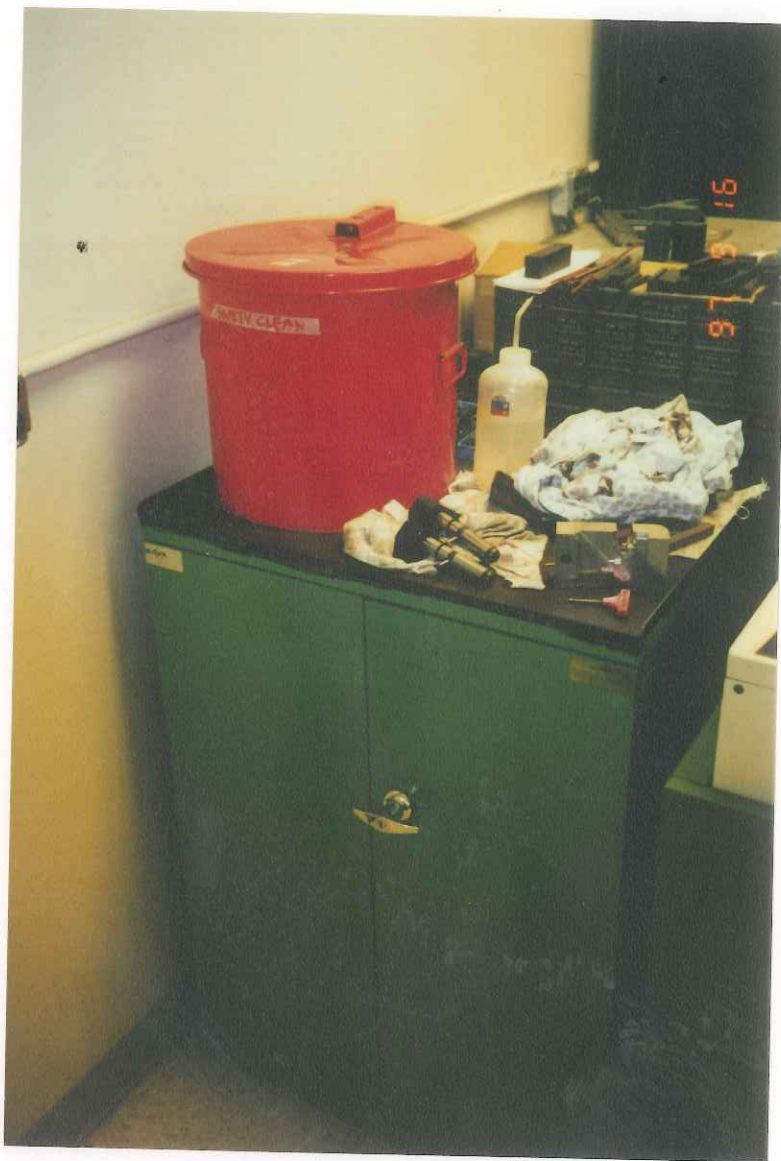
Report Photo No.: 6
Log Book Photo No.: 1-11
Date: 09/16/97

Description: View showing the Safety Kleen Parts Washer unit located in the molding room (SWMU 3c). The unit is a 5 gallon pail placed on top of a cabinet.

(c) - Molding Room. This unit is a small, lidded pail estimated to be five gallons in capacity. The drum rests directly upon a cabinet, over a linoleum tiled floor. No stains or cracks were observed in the unit, which has been operational since 1990.

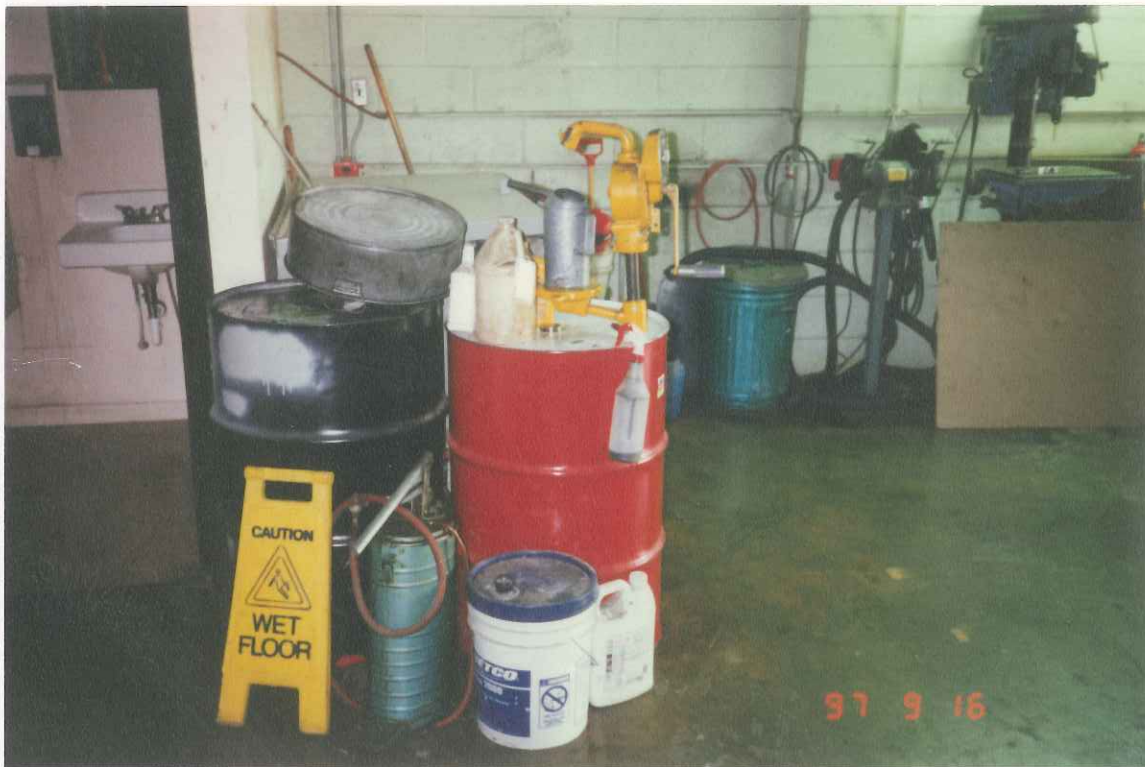
Report Photo No.: 7

Description: View showing a Safety Kleen Parts Washer container located in the Maintenance Shop (SWMU 3d). The unit is a 55 gallon drum resting directly on a sealed concrete floor.

(d) - Maintenance Shop. This unit is a 55 gallon drum resting directly on a sealed concrete floor. The floor appeared to be free of stains and cracks at the time of the VSI. This unit has been operational since before 1990.

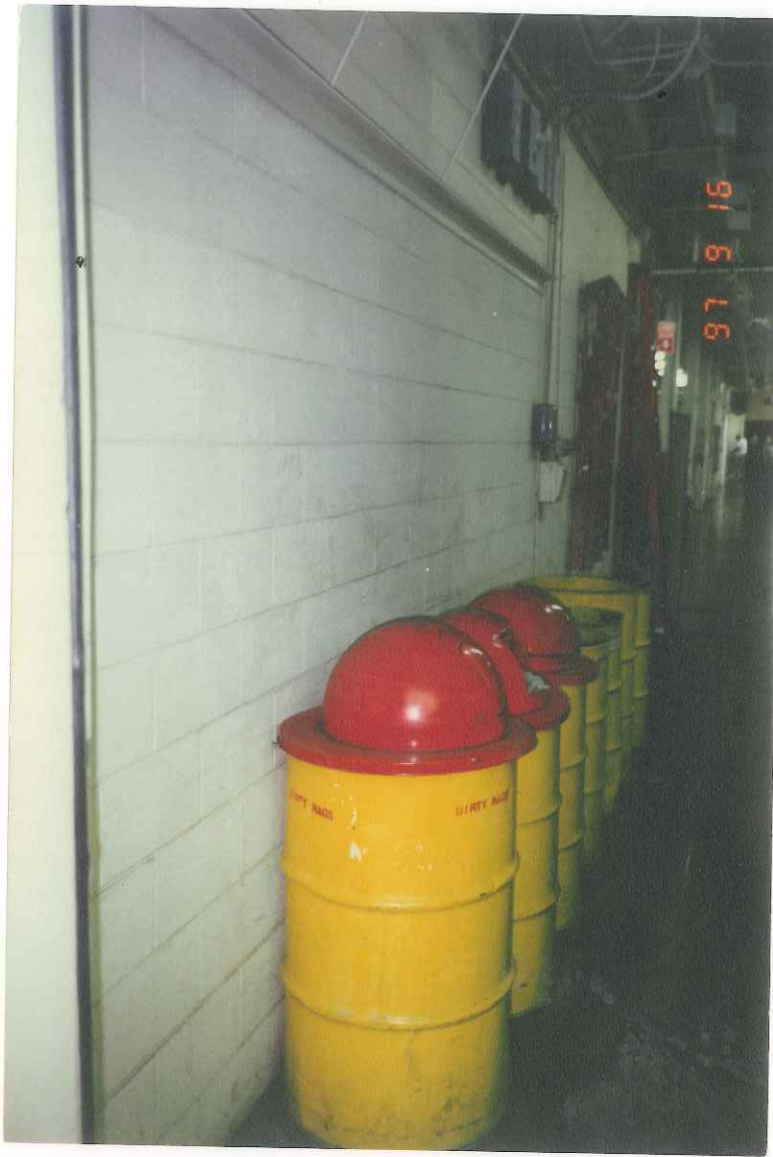
Report Photo No.: 8
Log Book Photo No.: 1-2
Date: 09/16/97

Description: View showing Rag Collection Drums located in the main building near the doorway leading into the Scrap Dock Area (SWMU 4).

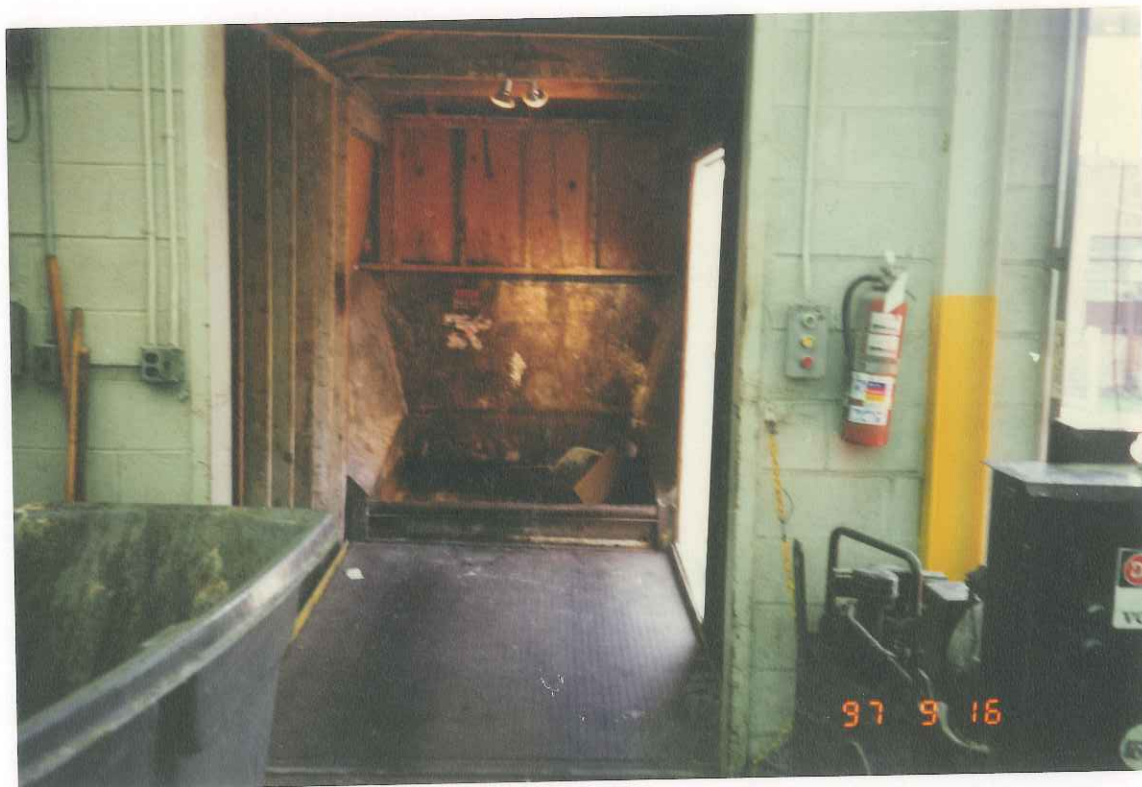
Report Photo No.: 9

Description: View of the Trash Compactor (SWMU 4a) located along the southern wall of the Scrap Dock Area (SWMU 4).

4a - Trash Compactor (Report Photo No. 9). This unit is a mechanical compactor that serves as the receptacle for non-hazardous solid waste which cannot be recycled and is being shipped off-site for disposal. It is located along the southern wall of the loading dock and receives cafeteria wastes, non-recyclable scrap wooden pallets, non-recyclable scrap molding, flashing from the molding parts, ash from the burn-off unit, spent filters and powder from the paint line, and miscellaneous office and process area trash. Compacted wastes are removed from site on a routine basis by Waste Management West, formerly known as Fox Valley Disposal. This unit has been operational since before 1970.

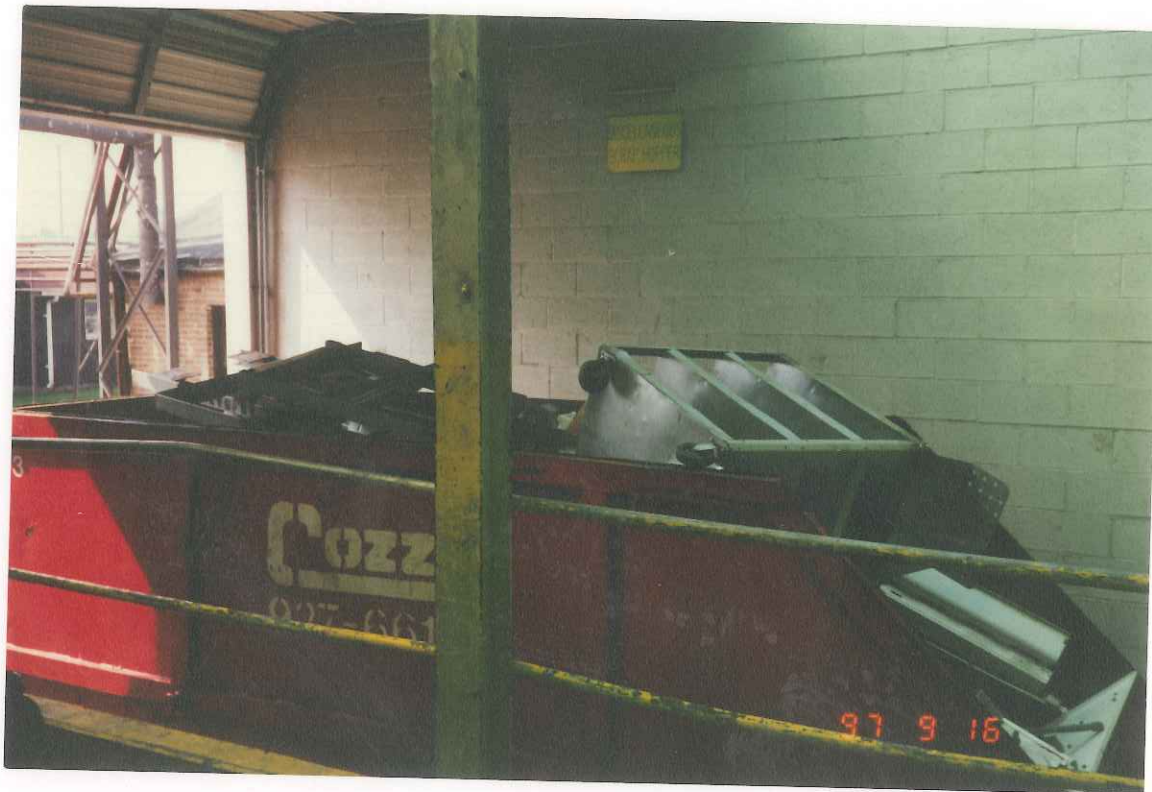
Report Photo No.: 10
Log Book Photo No.: 1-4
Date: 09/16/97

Description: Miscellaneous Painted Scrap Metal Hopper located inside a sloped concrete receiving area that is adjacent to the Trash Compactor (SWMU 4a).

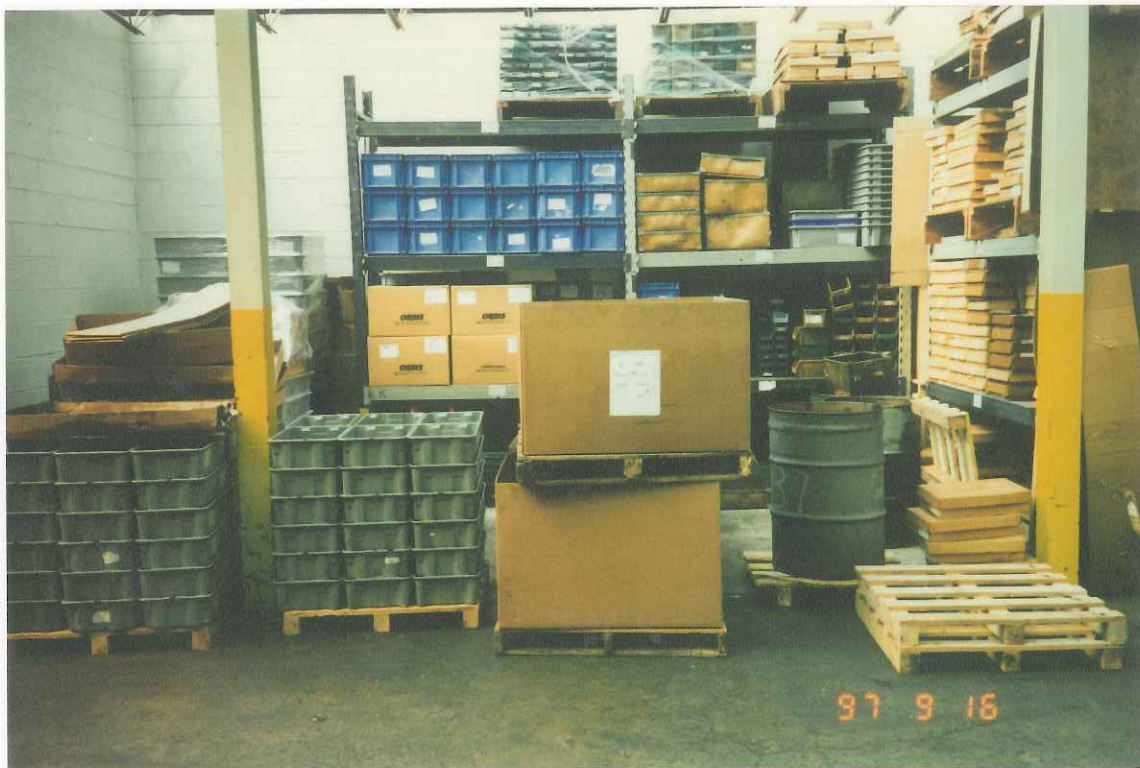
Report Photo No.: 11

Description: View of Scrap Metal Storage Area (SWMU 4d) located in the central portion of the Scrap Dock Area (SWMU 4). Each of the containers visible in the photograph was filled with a particular type of metal scrap.

4d - Scrap Metal Storage Area (Report Photo No. 11). This area is located along the western wall and central portion of the scrap dock area. It is designated for storing recyclable metals prior to off-site shipment. At the time of the VSI, 13 drums of metal scrap, sorted according to type, and several smaller bins of scrap material were observed. This unit has been operational since 1965.

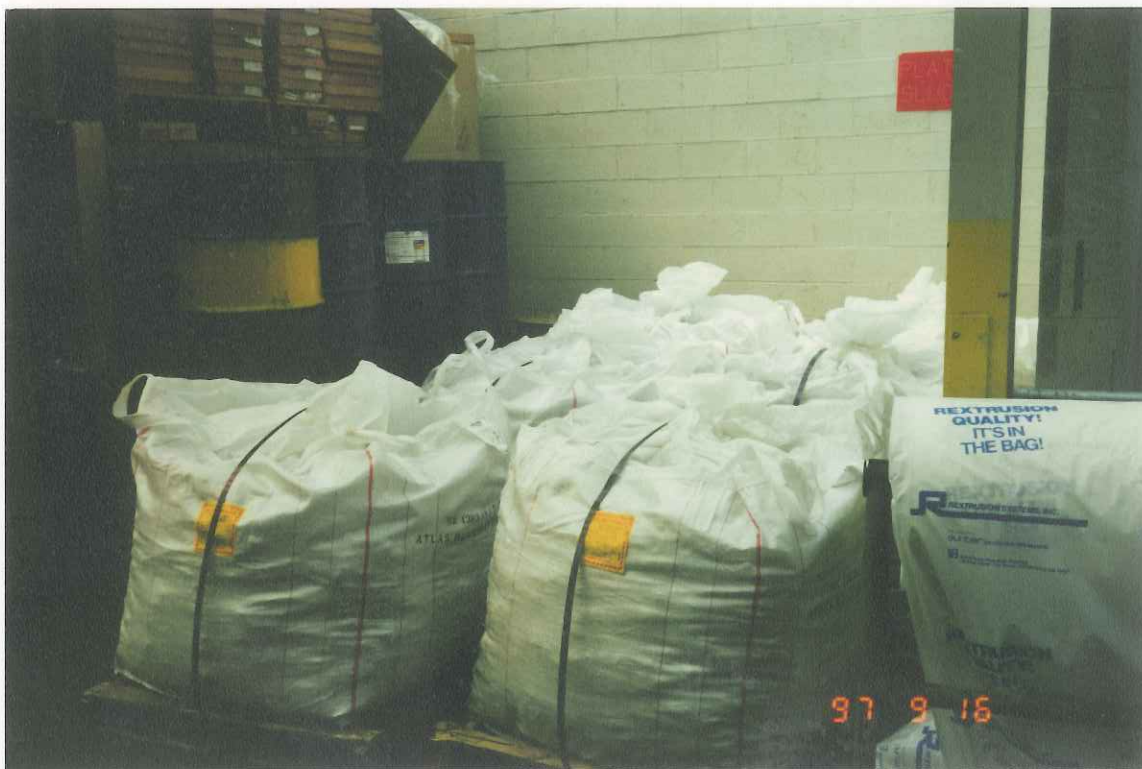
Report Photo No.: 12
Log Book Photo No.: 1-6
Date: 09/16/97

Description: View showing the Metal Hydroxide Sludge Storage Area (SWMU 4e) located in the Scrap Dock Area (SWMU 4) between the Scrap Metal Storage Area (SWMU 4d) and the Unpainted Scrap Metal Hopper (SWMU 4f). The white bags visible in the foreground contain metal hydroxide sludge.

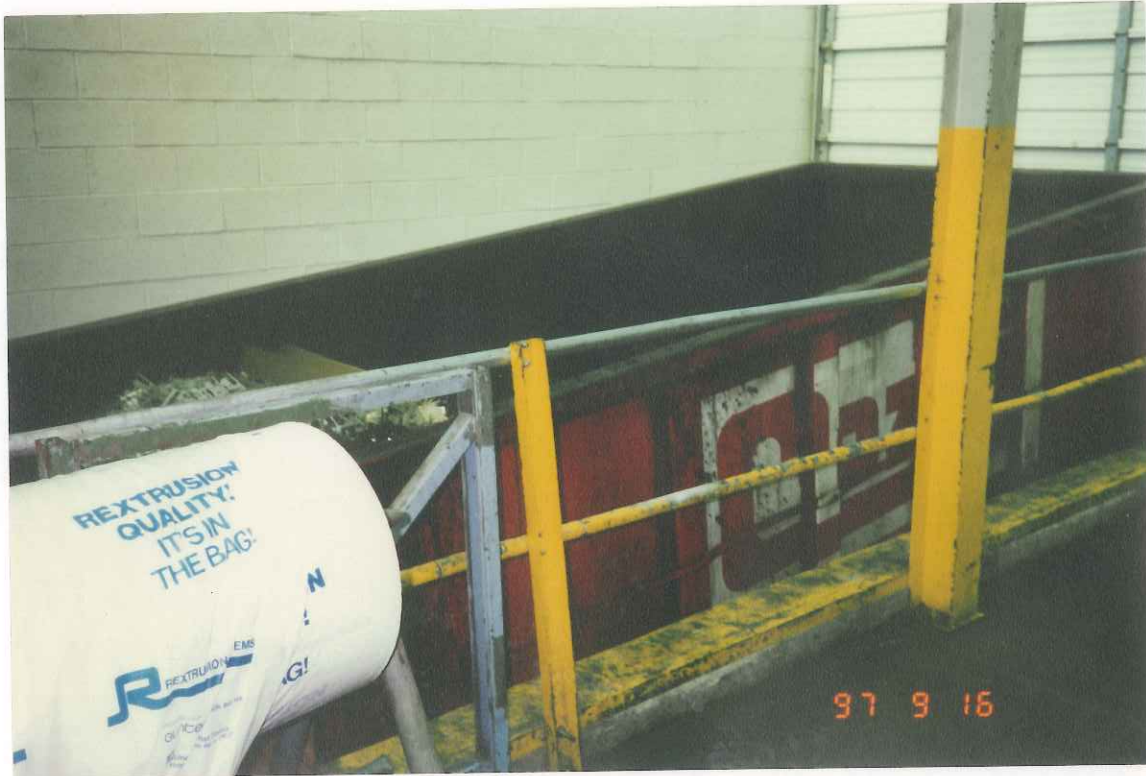
Report Photo No.: 13

Description: View showing the Unpainted Scrap Metal Hopper and Associated Oil Sump (SWMU 4f) located in the Scrap Dock Area (SWMU 4). The unit has a capacity of approximately 20 to 30 cubic yards. It is used for managing unpainted scrap metal parts. Note that the Associated Oil Sump is not visible in the photo.

Unpainted Scrap Metal Hopper (SWMU 4f). This is a temporary storage area for bags of hazardous metal hydroxide sludge (F006). The wastes are brought to this area from the Plating Line Pretreatment System Filter Press (SWMU 15h). At the time of the VSI, the unit contained six bags of waste. The bags rest directly on wooden pallets over a sealed concrete floor. The unit is equipped with a 12 - inch high containment curb on three sides of the storage area (south, west, and north). Facility representatives indicated that the wastes are stored for less than 90 days prior to off-site shipment for treatment and disposal by Envirite. This unit has been operational since 1992.

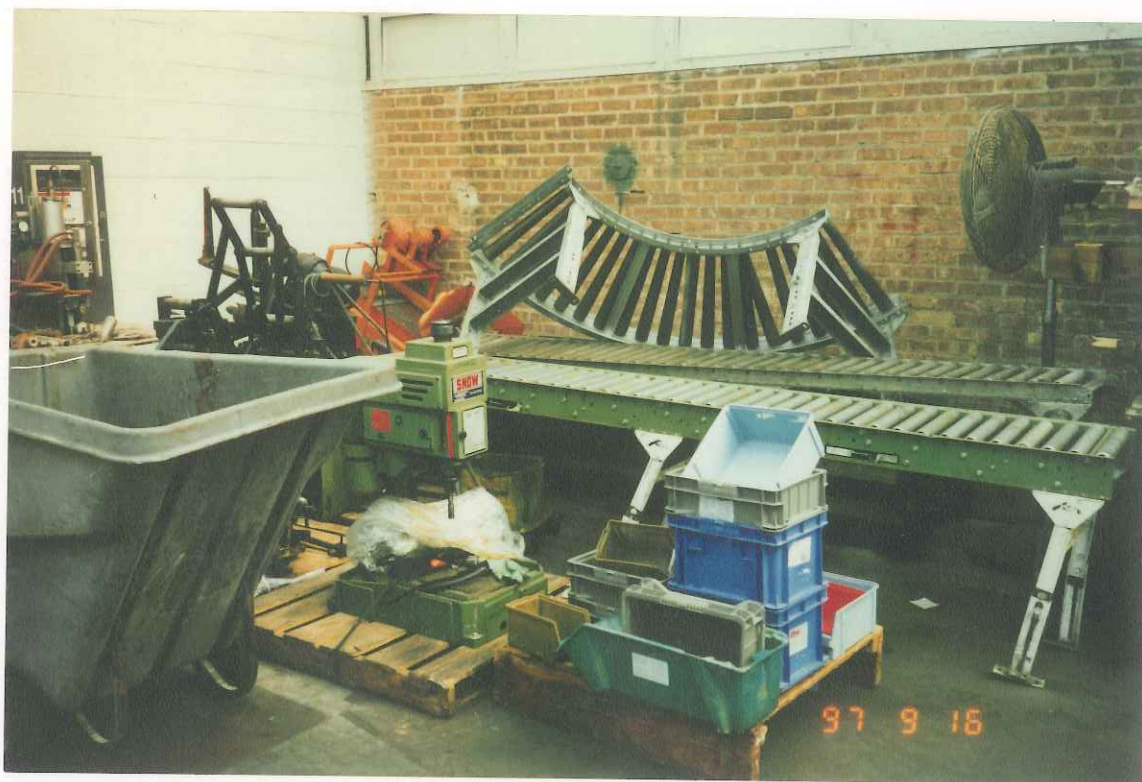
Report Photo No.: 14

Description: View showing Former Waste TCE/Metal Hydroxide Sludge Storage Area (SWMU 4g) located in the Scrap Dock Area (SWMU 4). This unit is an area that was formerly designated for the storage of waste TCE and metal hydroxide wastes. It is currently used for storing equipment parts.

4g - Former Waste TCE/Metal Hydroxide Sludge Storage Area (Report Photo No. 14). This unit is an area of the loading dock that was formerly designated for the storage of hazardous wastes. Both metal hydroxide sludge and spent TCE were stored in this unit from 1992 to more recently when the storage area was moved across the aisle. Like the present storage area, this unit was equipped with containment curbing along the west, north and east wall. The floor of the area was a sealed, concrete floor. At the time of the VSI, minor cracks were observed but no stains were visible. This area is currently used for storing equipment parts.

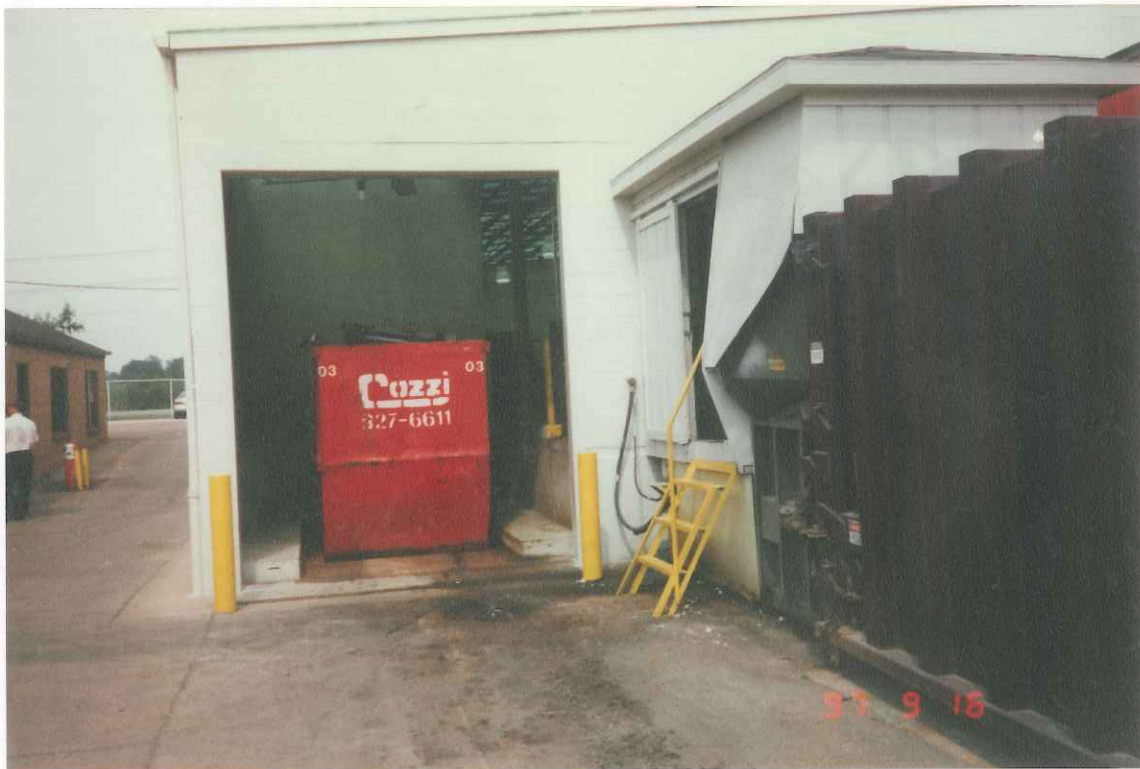
Report Photo No.: 15
Log Book Photo No.: 2-1
Date: 09/16/97

Description: View showing the Scrap Loading Dock (SWMU 4b) area. The unit to the right which has a yellow staircase leading from it is the Trash Compactor (SWMU 4a).

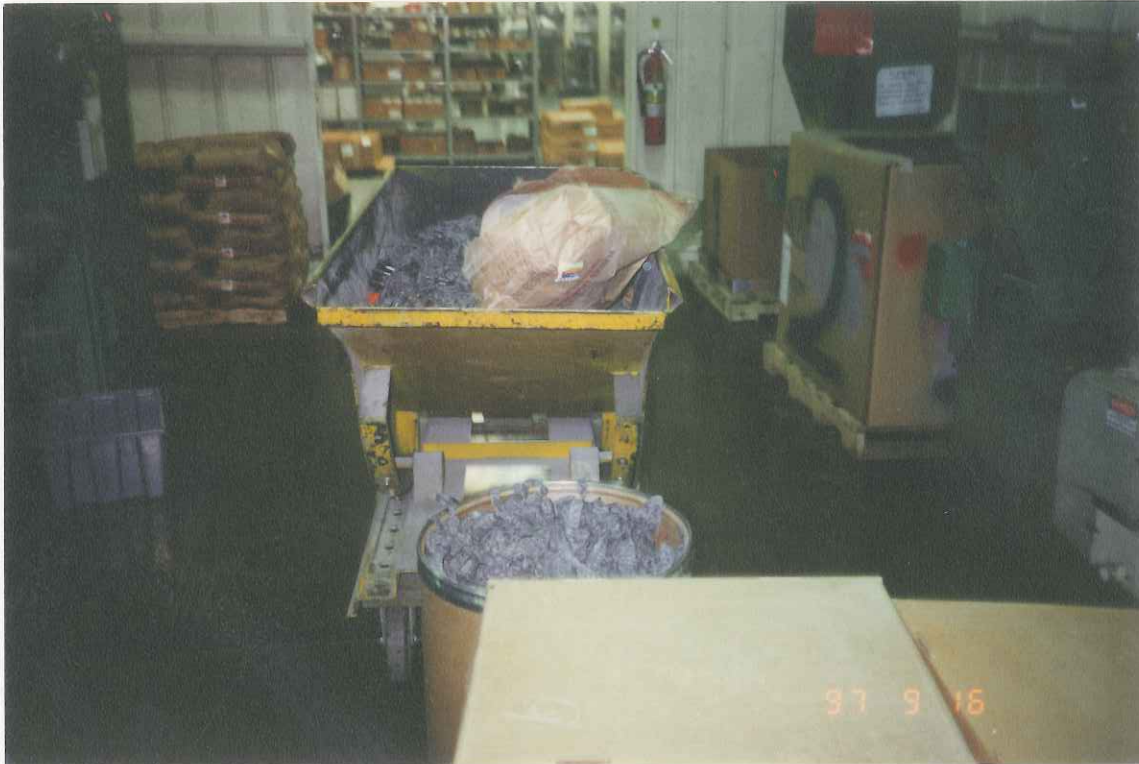
Report Photo No.: 16
Log Book Photo No.: 1-10
Date: 09/16/97

Description: View showing a Representative Scrap Molding Hopper (SWMU 6). These units are located in several locations throughout the Molding Department. The representative unit shown in the photograph consists of a hopper containing 2 to 3 cubic yards of scrap molding and a 55 gallon cardboard drum filled with scrap molding.

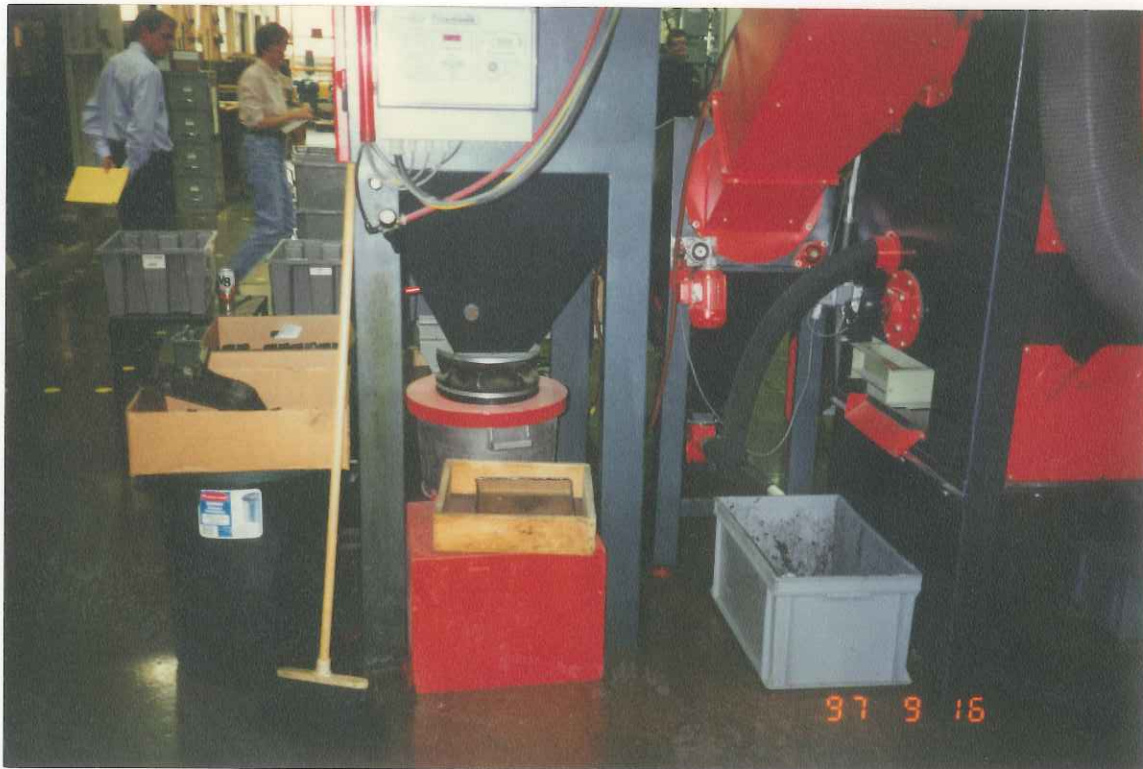
Report Photo No.: 17
Log Book Photo No.: 1-12
Date: 09/16/97

Description: View showing a Molding Deflashing Refuse Container (SWMU 7) located in the facility's molding department. The unit is a 20 gallon plastic container. It is used to collect spent plastic beads and "filings" from the Deflashing machine.

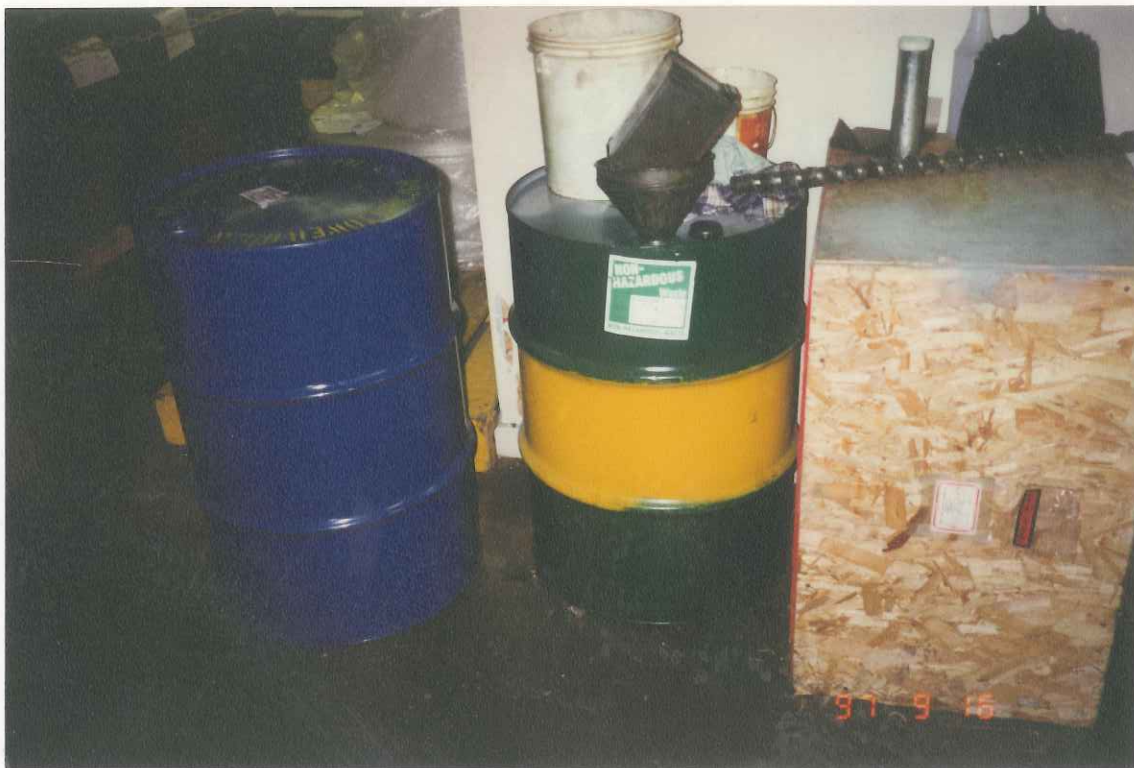
Report Photo No.: 18
Log Book Photo No.: 1-13
Date: 09/16/97

Description: View showing the Hydraulic Oil Collection Drum (SWMU 8) located in the carton stores department. The unit (colored yellow and green) is a 55 gallon drum used to collect oil from the facility's hydraulic equipment. Once full, the drum is taken to the Oil House (SWMU 10) prior to shipment off-site for reclamation.

Physical Description: This unit is a 55-gallon drum used to collect oil from the hydraulic units in the production area. Periodically, the oil is manually pumped from the process units, filtered, and returned to the unit. The collected filtrate is then drained into the Hydraulic Oil Collection Drum. Once full, the drum is taken to the Oil House (SWMU 10) prior to shipment off-site for reclamation. The drum rests directly on the sealed concrete floor which was free of cracks and stains at the time of the VSI.

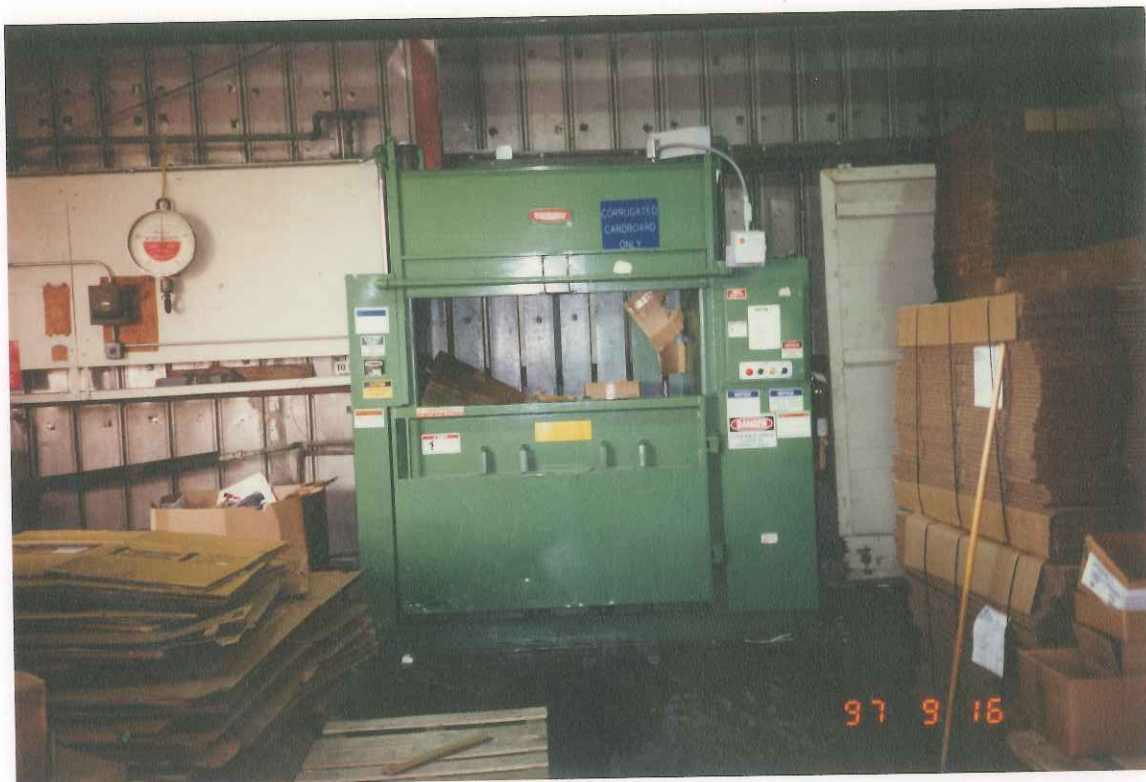
Report Photo No.: 19
Log Book Photo No.: 1-14
Date: 09/16/97

Description: View showing the Scrap Cardboard Compactor (SWMU 9) located in the steel stores department. The unit is used for compressing and bundling corrugated cardboard boxes into smaller packages for easier transportation off-site.

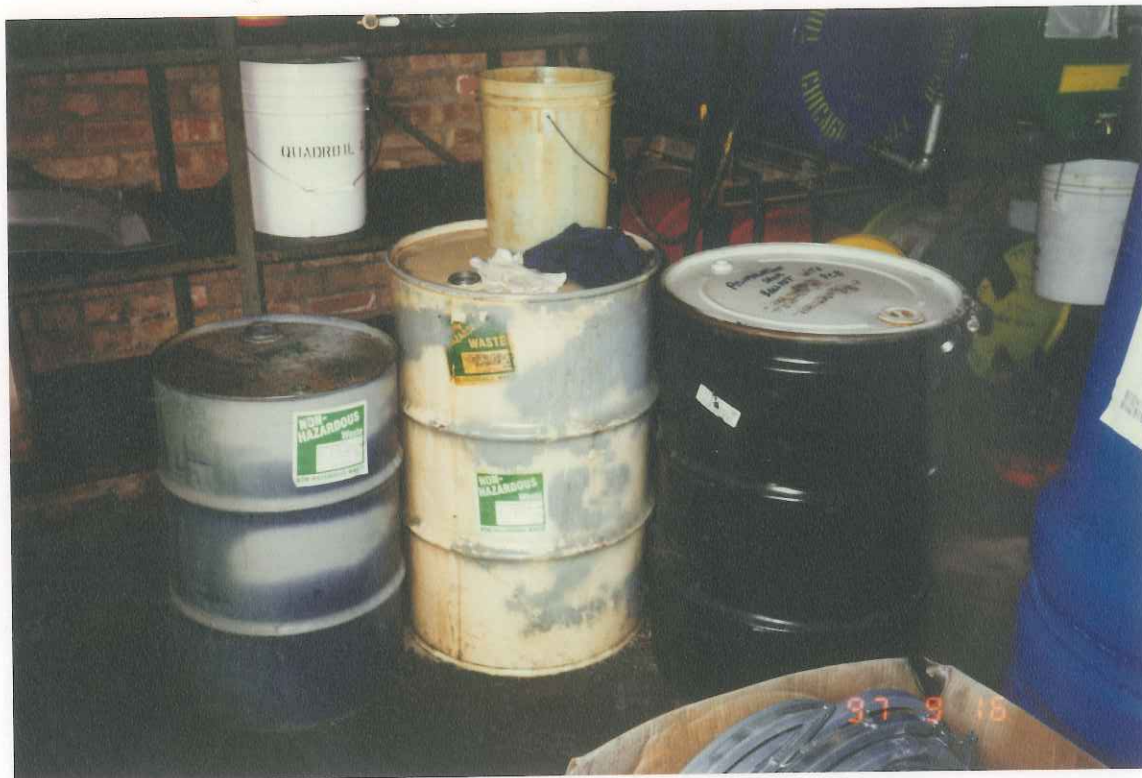
Report Photo No.: 20
Log Book Photo No.: 1-17
Date: 09/16/97

Description: View showing two drums of non-hazardous waste oil and one 55 gallon drum (black) containing PCB-contaminated ballasts. The containers are stored inside the Oil House (SWMU 10). Besides containers of non-hazardous waste oil, drums of PCB-contaminated ballasts and raw materials are stored in the Oil House (SWMU 10).

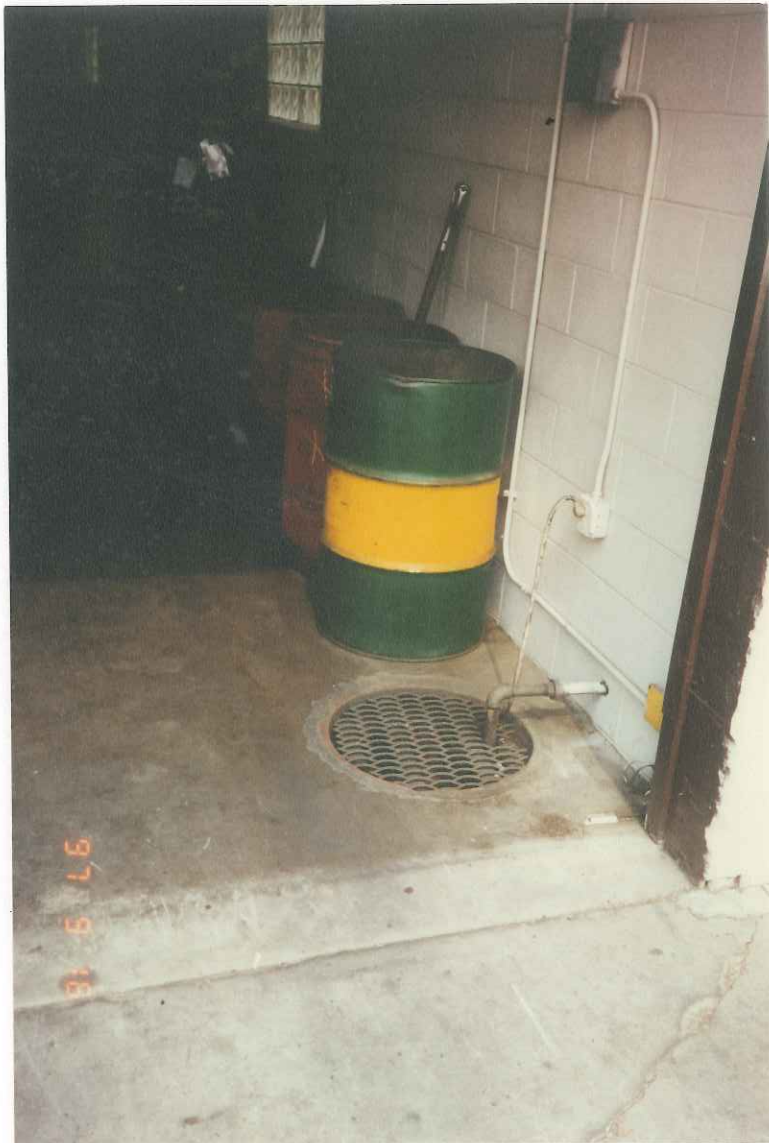
Report Photo No.: 21

Description: View showing the Corner Rain Water Sump (SWMU 11) located in the screw machine room. Immediately behind the sump is the Screw Machine Floor Washings Collection Drum (SWMU 12), which is an open 55 gallon drum used for temporarily storing floor washings from the screw machine room.

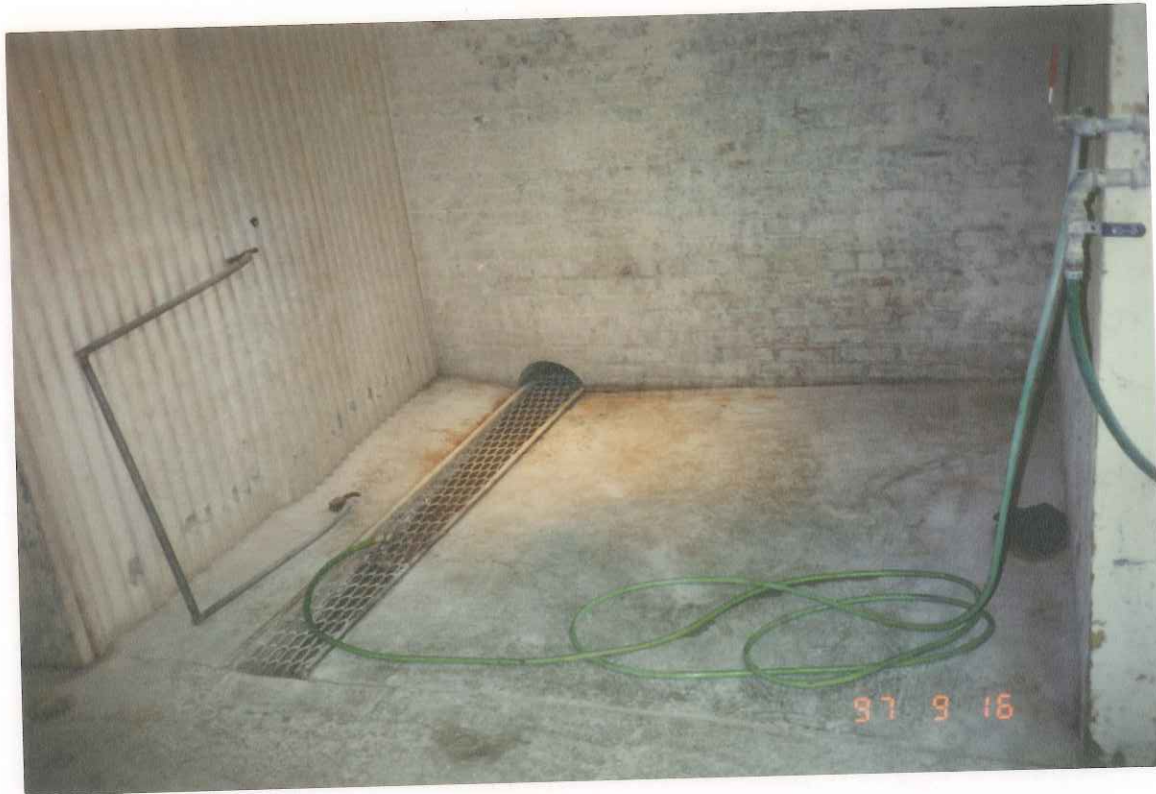
Report Photo No.: 22
Log Book Photo No.: 1-20
Date: 09/16/97

Description: View showing the Strip Room Wash-Off Area (SWMU 13). The unit measures approximately 3 yards by 2 yards. Waste wash-off water drains into the covered trough and eventually into the facility's wastewater pretreatment system.
